Section 5

34. Erratic Unit Operation (3-25 ton)

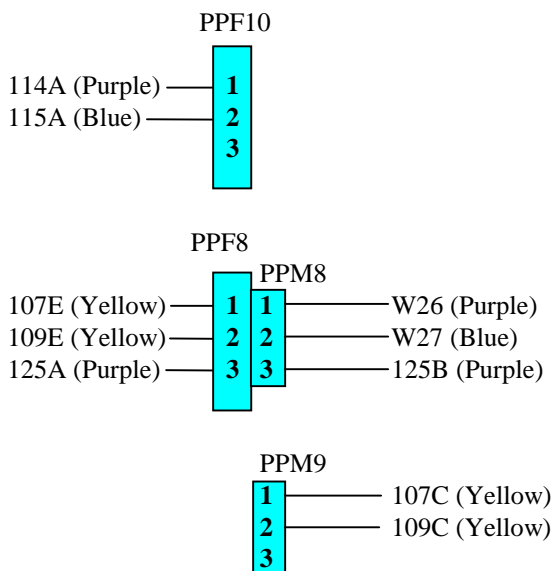
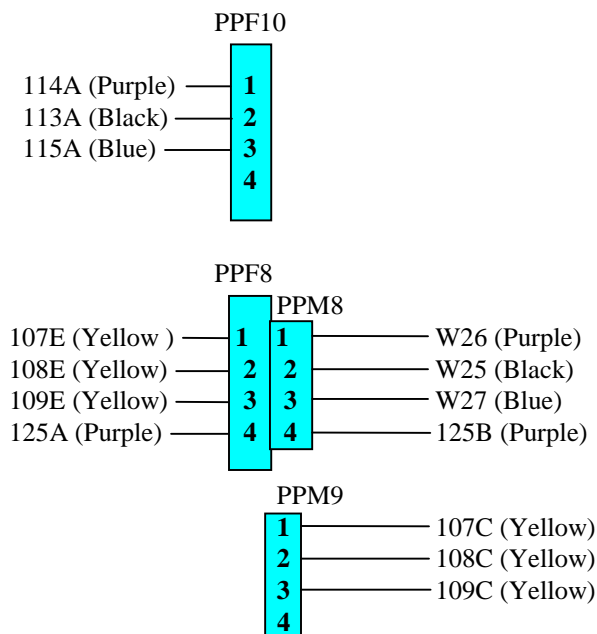
When an economizer, motorized outside air damper, or generic input/output module is installed, these plugs must be re-configured. If the polarized plugs (PPM8, PPF8, PPM9, and PPF10) in the unit control box are not configured properly, erratic operation can occur.

On equipment with “NO” economizer or motorized outside air damper, the plugs should be configured as illustrated below.

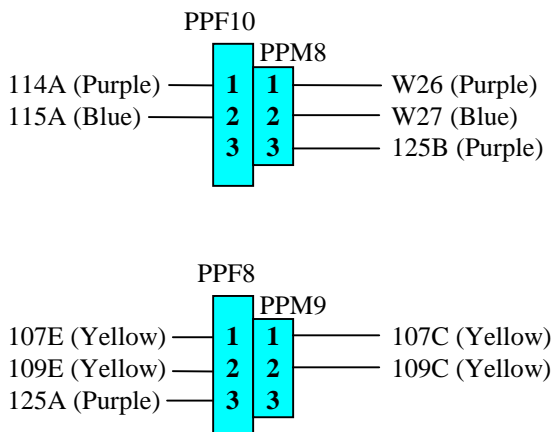
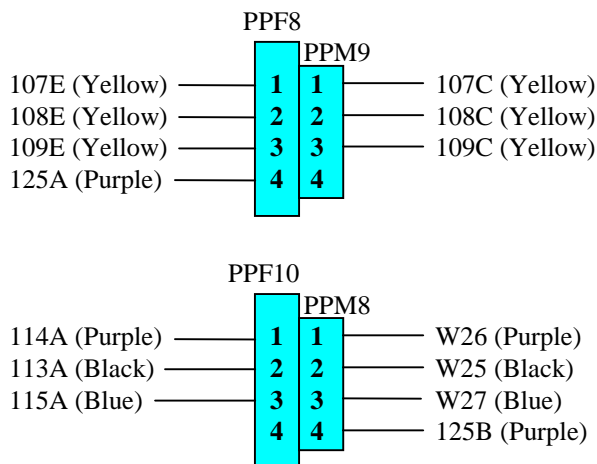
On equipment *with* an economizer, motorized outside air damper or BAYDIAG001A, the plugs should be configured as illustrated below.

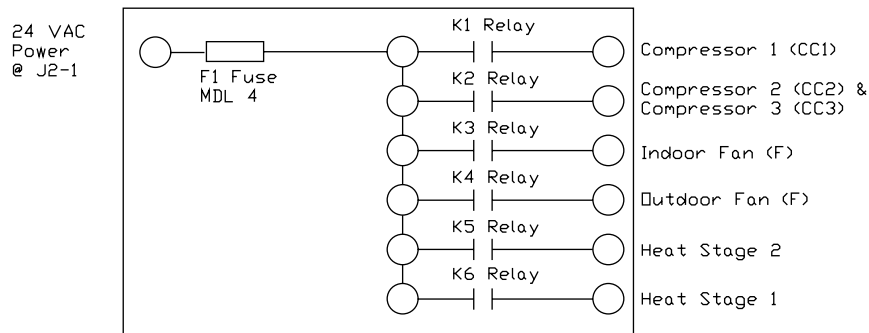
35.1. A UCP on board relay may have failed:

The weakest link on a printed circuit board, under normal operating conditions, is the on board electromechanical devices (primarily relays). These are the “only” moving parts on a printed circuit board. If a particular device in a piece of equipment will not turn “ON” or “OFF”, some electrical measurements may be made to determine the source of the problem.

To determine the source of the problem, remove power from the equipment at the service disconnect, and utilize the system schematic diagram to determine where to install meter leads.

For devices that are not de-energized: An “Ohm meter” should be installed across the on board relay contacts, to determine if they are opening when power is removed from the equipment. A short circuit indicates the contacts are welded.

For devices that are not energized: An “AC volt meter” should be installed across the on board relay contacts, of the Unitary Control Processor (UCP) for that device.

Re-apply power to the equipment, and operate the system in the suspect mode, to determine if the relay contacts are closing or not. A voltage potential of 24V AC indicates the contacts are not closing, zero potential indicates they are closed.

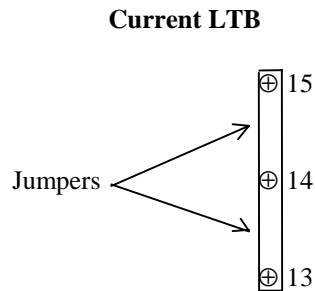
35.2. Brass jumpers for compressor disable input are loose, corroded or missing:

If the brass jumpers on the Low Voltage Terminal Board (LTB) are loose, corroded, or have been removed, the compressor(s) affected will not operate during normal operation, or in the Test mode.

Verify that the brass jumpers are intact, on equipment manufactured prior to 06/93 there should be two brass jumpers between terminals LTB-13, 15, and 17. On equipment manufactured after 06/93 there should be two brass jumpers between terminals LTB-13, 14, and 15. If the brass jumpers are intact, verify that the terminals are tight, and that they are not corroded. A voltage measurement may be made to verify that 24V AC is being applied to the compressor disable inputs. This is accomplished by measuring from terminal J2-2 to ground (CPR1 DISABLE), and from terminal J2-3 to ground (CPR2 DISABLE).

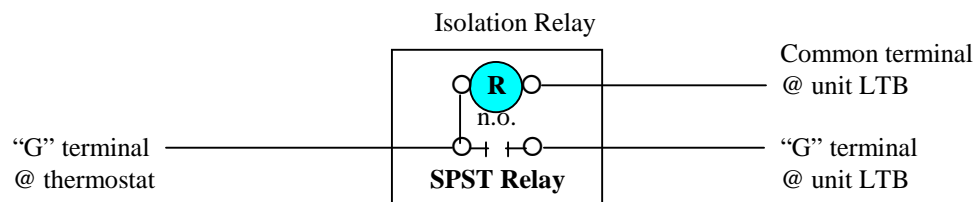
Isolation Relay Example with Leakage Current in "G" Circuit

If the conventional thermostat interface (CTI) is disconnected, the low voltage terminal board (LTB) is jumpered, and the unit is operating; there may be excessive leakage current from an electronic/programmable thermostat, because the thermostat does not have dry contact closure relays. If enough leakage current passes through the thermostat being used, it can cause the microcontrol Voyager to operate (heat, cool, fan on, etc.), when it is supposed to be "OFF". The maximum allowable leakage, before it is in the gray area where it may be interpreted as an "ON" state (or call), is 4V AC. To test for leakage, turn the thermostat "OFF", so that there is no active call for any operation. Using a voltmeter, measure the AC voltage from each circuit (Y1, Y2, W1, W2, G etc.) to ground, for proper operation there should not be more than 4V AC. If there is more than 4V AC present, in any circuit, an isolation relay should be installed as illustrated below.

Note: If you have a thermostat set where it is supposed to be cooling, and there is enough leakage current in the heat circuit, the Voyager will interpret the signals as a simultaneous call for heating and cooling. However, the microprocessor in the Voyager is programmed so that it will not allow simultaneous heating and cooling. The machine will sit idle and not operate at all, except in the test mode.

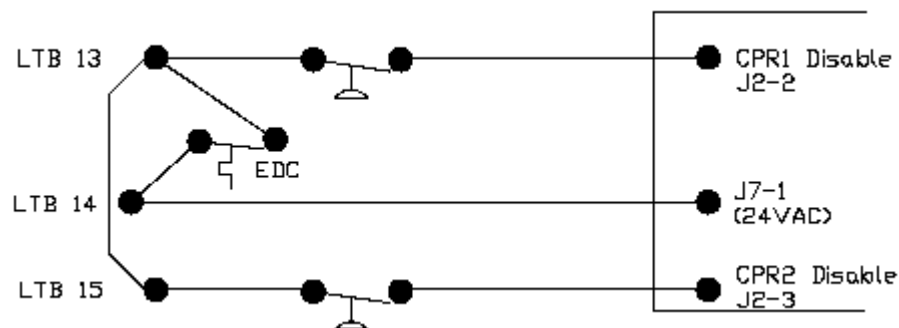
Electrical Diagram For Installing An EDC In A Voyager System

41.1. Installing a direct sensing evaporator defrost control (EDC):

Since the Voyager products do not have a direct sensing means of keeping ice off of the evaporator coil, it may be necessary (in certain applications) to install an external, direct sensing Evaporator Defrost Control (EDC).

Note: Substitute LTB-15 for LTB-14 On Equipment Manufactured Prior To 06/93

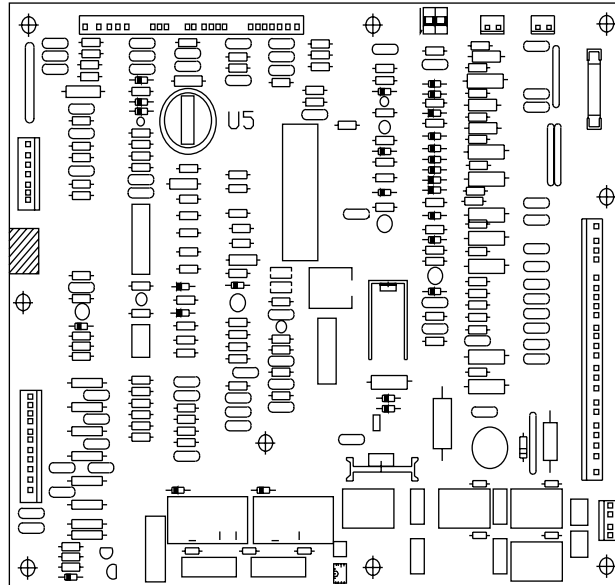
Multiple Unitary Control Processor (UCP) U5 Chip Failures

The U5 chip illustrated below, is a 29V DC relay driver that is used to energize off board relays and the Zone Sensor Module (ZSM) LEDs. This chip will fail if AC voltage is applied to one of its outputs, or if an output is grounded or over powered.

A factory or field mis-wire, or arbitrary jumpering of the terminals at the LTB may result in the accidental application of 24V AC to one of U5s 29V DC outputs. If this occurs, the negative half wave of the AC voltage will fail the U5 chip. A failed chip can be easily identified; a piece of the chip may be missing (looks like a crater in the chip), or a bubble or crack will appear in the chip.

The coil is 24VDC, not 24VAC. If AC relay coils are applied on these DC circuits, without modifications, it will ultimately fail the U5 chip and the relay. The relay coil will overheat and the wire insulation will burn off, causing the coil to short, pulling excessive current (over powering the output) and eventually causing complete failure. If U5 chip failures occur, check for wiring errors, both field and factory at the LTB.

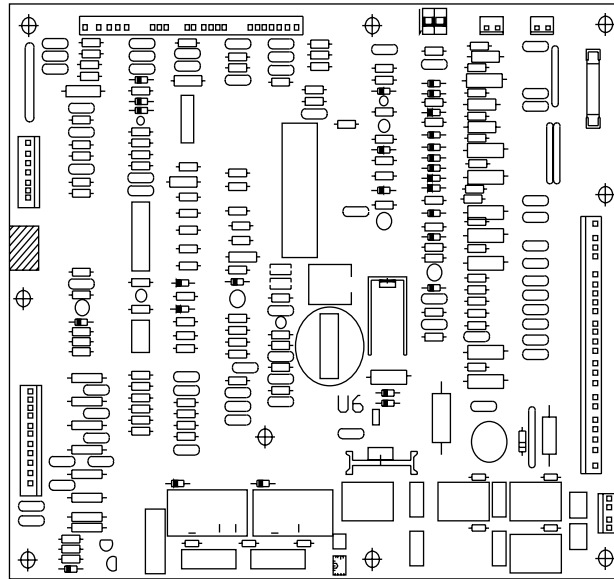
Multiple Unitary Control Processor (UCP) U6 Chip Failures

The U6 chip illustrated below is a 29VDC relay driver that is used to energize on board and off board relays. This chip will fail if an output is grounded or over powered.

The coil is 24VDC, not 24VAC. If an AC relay coil is applied on this DC circuit, without modifications, it will ultimately fail the U6 chip and the relay. The relay coil will overheat and the wire insulation will burn off, causing the coil to short, pulling excessive current (over powering the output) and eventually causing complete failure. If U6 chip failures occur, also check unit wiring harness and economizer / motorized outside air damper harness.
